# Manhole Inspection Summary

Manhole # S31GG\_062MH

**Location** Address: **225 BOLTON ST**

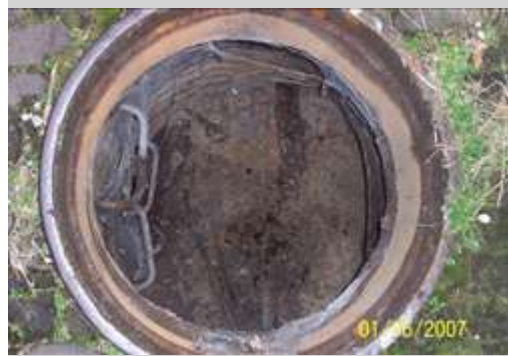
Top View

Channel debris.

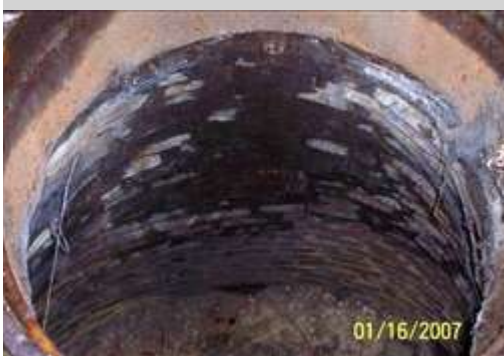
Defect

Condition: ☐ Sound ☐ Cracked ☒ **Root Intrusion** ☐ Loose Brick ☒ **Deteriorated**

Infiltration: ☐ None ☒ **Joint** ☐ Cracks ☒ **Mortar** ☒ **Roots** ☐ Wall

Infiltration: ☐ None ☐ Joint ☐ Cracks ☒ **Mortar** ☐ Roots ☒ **Wall**

Frame leaks. Adjustment deterioration, root intrusion and infiltration. Corbel infiltration.

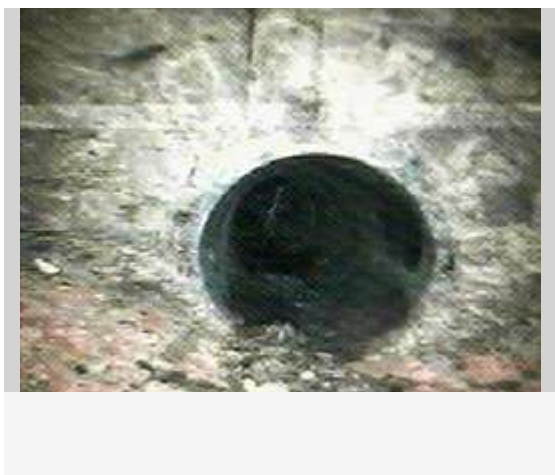
8 in. Circular Gravity Sewer  
Pipe Out @ 12 O'Clock

Deposits: ☐ None ☐ Mud ☐ Sludge ☒ **Debris** ☒ **Grease**
